Risk Report (Preliminary)

Amsted Industries Incorporated
Consolidated Metco, Inc.
13940 North Rivergate Blvd
Portland, Oregon 97203
USA

Fire & Natural Hazards
Baseline Risk Evaluation
Visit by Douglas F. Burnett on
05 May, 2003 in conference with
Mr. Tom Duncan, Plant Manager

All in One Baseline Risk Evaluation

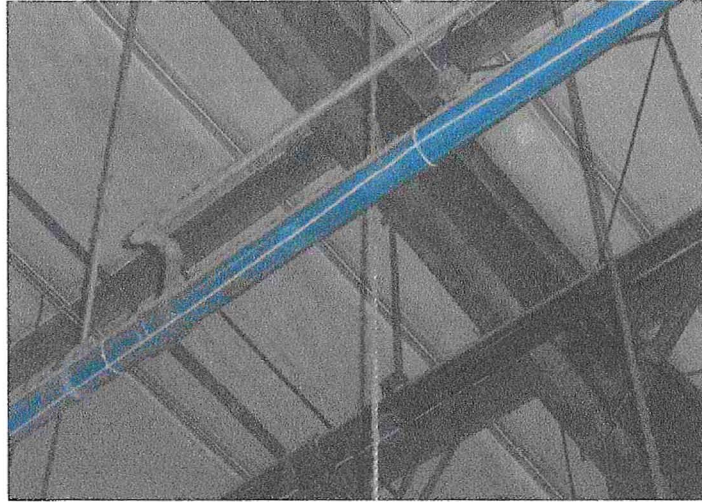
Remove Combustible dust and lint off sprinkler mains and building members in production buildings.

Combustible dust accumulations should be removed. As part of a regular housekeeping schedule, the reduction of dust accumulation on equipment, fixtures, sprinkler piping/heads, building elements, etc., should be given high priority.

Excess dust and lint can create a fire or explosion hazard. If dust from building members or sprinkler piping is suspended in air a fire or explosion can result causing massive damage to equipment, product and building.

Dust/Lint on Piping and Building Members

Dust and lint accumulations on piping and building members has been removed in the production buildings. Cleaning of these deposits is to be done annually in the future through the PM system. This completes former Recommendation 03-05-002 and it has been removed from this report.

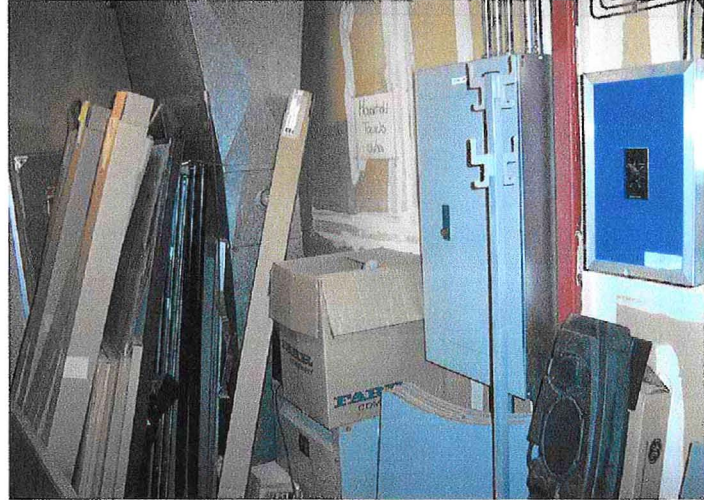
Combustible loading near electrical panels combines a ignition source and fuel for a fire. In the event of an electrical malfunction, the fuel (cardboard, paper, etc.) could be ignited and a subsequent fire would occur.

Combustible Storage Near Electrical Panels

Add the office building electrical rooms to the Monthly inspection program.

A program should be established for inspecting and maintaining good housekeeping practices in the office building.

The electrical room in the Office Building has been emptied of excessive combustible storage and is now monitored periodically to see that this room remains free of combustible storage. This completes former Recommendation 03-05-003 and it has been removed from this report.

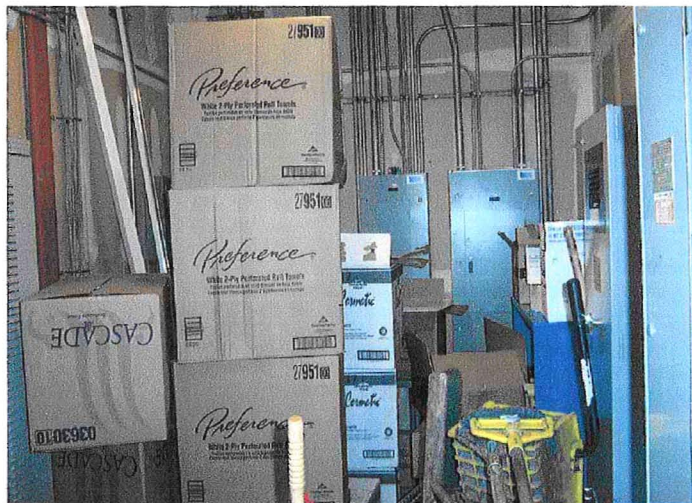
Automatic sprinkler protection has proven to be the best defense against a major fire loss in structures that have either combustible construction and/or a combustible occupancy. Without sprinkler protection, a fire event in an electrical room could potentially destroy the wood constructed building. Although production controls are not housed in the office building, many essential duties such as engineering, accounting, etc. are and would be lost in a fire event.

Combustible Loading Near Electrical Panels Without Sprinkler Protection

Install automatic sprinkler protection in the Main Office building.

Automatic sprinkler protection should be installed throughout the Main Office building. The system should be capable of providing a density of 0.10 gpm/sq. ft. over the hydraulically most remote 1500 sq. ft., including an outside fire hose allowance of 250 gpm.

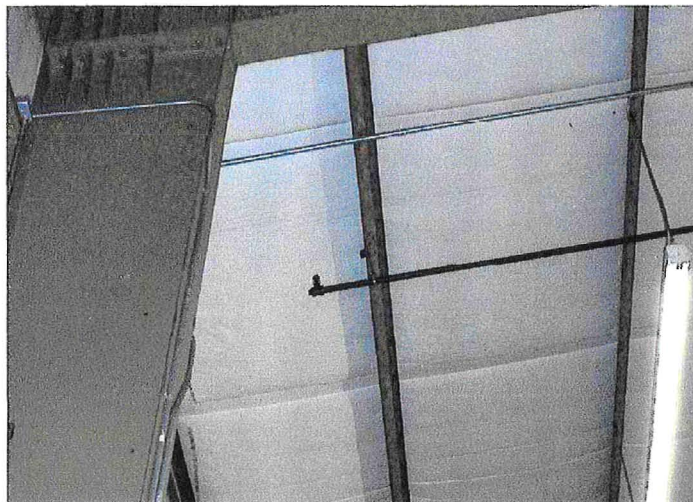
C-Clamp

Install adequate earthquake protection to the water-based automatic sprinkler systems. Deficiencies include lack of adequate four-way bracing at the risers, lateral and longitudinal bracing along the mains, and proper hangers at the mains. Before any work is undertaken, a complete review of the deficiencies should be completed. FM Global will work with the selected sprinkler contractor to assure that recommendations are understood and that criteria outlined in FM Global Property Loss Prevention Data Sheet 2-8 are met.

Without proper bracing, automatic sprinkler pipes can shake violently during a seismic event. If the seismic event is of great magnitude, the pipes can break resulting in water damage to goods and leave the manufacturing facility without protection from a fire.

Install adequate earthquake protection to the sprinkler systems in the Warehouse & Gusset bldgs.

Seismic bracing has been upgraded in the Warehouse and Gusset Buildings. This work was completed in March 2004 and was documented in a visit by FM Global at that time. A remaining issue from that visit was the bracing of the dry pipe sprinkler system riser and a far end lateral brace to building purlins rather than structural steel. Due to the small sizes of the piping involved (3 in. riser, 1-1/2 in. main), this bracing is accepted as adequate and Recommendation 00-12-010 has been removed from this report.

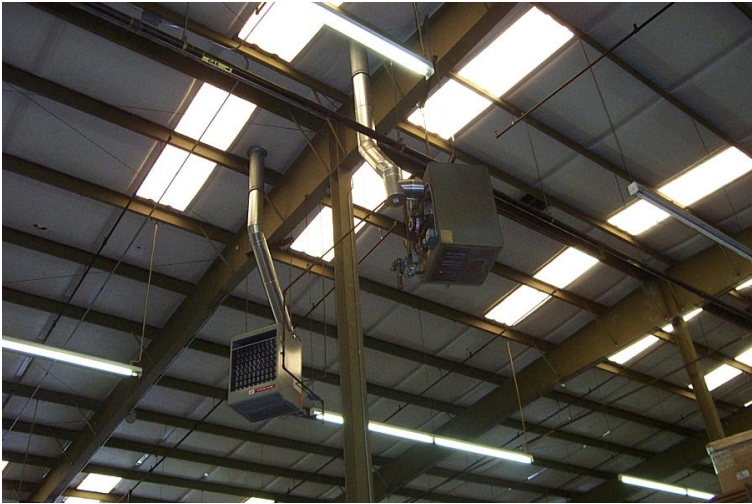
03-05-001	<p>Provide safeguards to prevent the release of flammable gases during a seismic event.</p> <p>The following items regarding existing natural hazard deficiencies at this facility should be considered:</p>
The Hazard	<p>The forces associated with a major earthquake often damage the integrity of gas systems, allowing gas to leak into the air. Escaping flammable gas provides ample fuel to support an explosion or supply a major fire. Typically, this flow of fuel continues unabated—a situation that frequently is worsened by concurrent breakage of unbraced automatic sprinkler piping, delayed public fire service response resulting from the need to focus on rescue operations, and the loss of fire service water supplies.</p>
<p>Part A.</p> <p>*Key Exposure*</p>	<p>Provide equipment restraint and flexible hose connections to all natural gas-fired equipment. (Last Revised 24 March 2005)</p> <p>For equipment supplied with bulk flammable gas, provide equipment restraint and, or, flexibility in flammable gas supply pipe connection. Flexibility should allow for 6 inches of movement in all directions. Equipment needing this protection includes the furnaces and ceiling space heaters.</p>

<p style="text-align: center;">Natural Gas Fired Space Heaters</p>
Status	<p>Mr. Tom Duncan, Plant Manager, agreed to work on providing anchorage and flexibility for the gas fired equipment. Bracing and flexibility needs were reviewed for several pieces of equipment during this visit.</p>

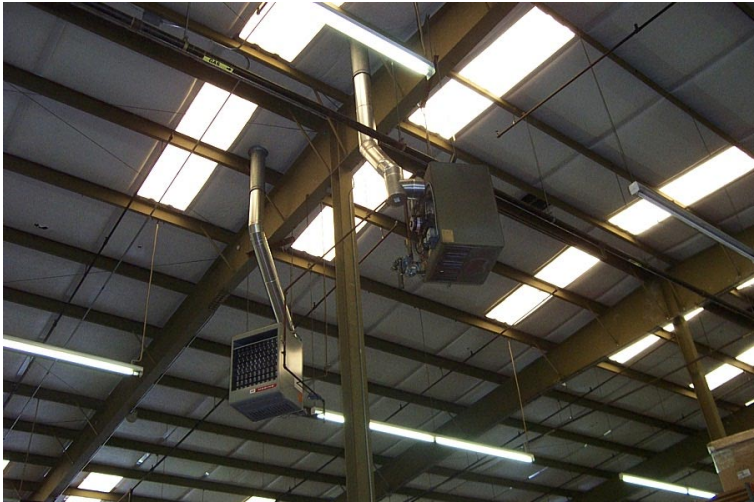
The Hazard	The forces associated with a major earthquake often damage the integrity of gas systems, allowing gas to leak into the air. Escaping flammable gas provides ample fuel to support an explosion or supply a major fire. Typically, this flow of fuel continues unabated, a situation that frequently is worsened by concurrent breakage of automatic sprinkler piping that lacks bracing. In addition, delayed public fire service response resulting from the need to focus on rescue operations, and the loss of fire service water supplies will occur.
-------------------	---

Natural Gas Fired Space Heaters

Part A. Provide equipment restraint and flexible hose connections to all natural gas-fired equipment.

For equipment supplied with bulk flammable gas, provide equipment restraint and/or flexibility in the flammable gas supply pipe connection. Flexibility should allow for six inches of movement in all directions. Equipment needing this protection includes the furnaces and ceiling space heaters.

Status	According to Mr. Bruce Post, the recommendation will be studied for possible completion.
---------------	--
